NASA TM-82470

PAST PERFORMANCE ANALYSIS OF HPOTP BEARINGS

By B. N. Bhat and F. J. Dolan
Materials and Processes Laboratory

March 1982

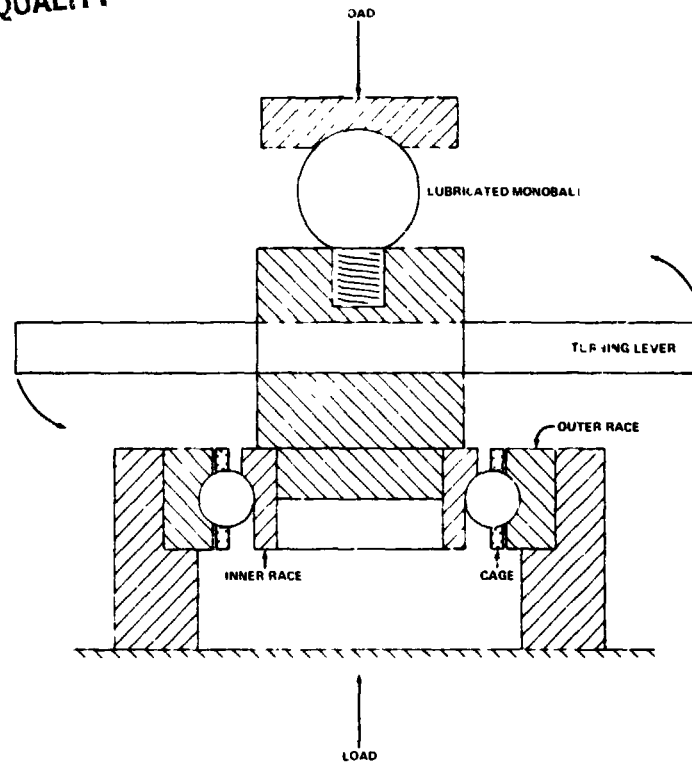
Figure 1. Arrangement for testing HPOTP bearing.

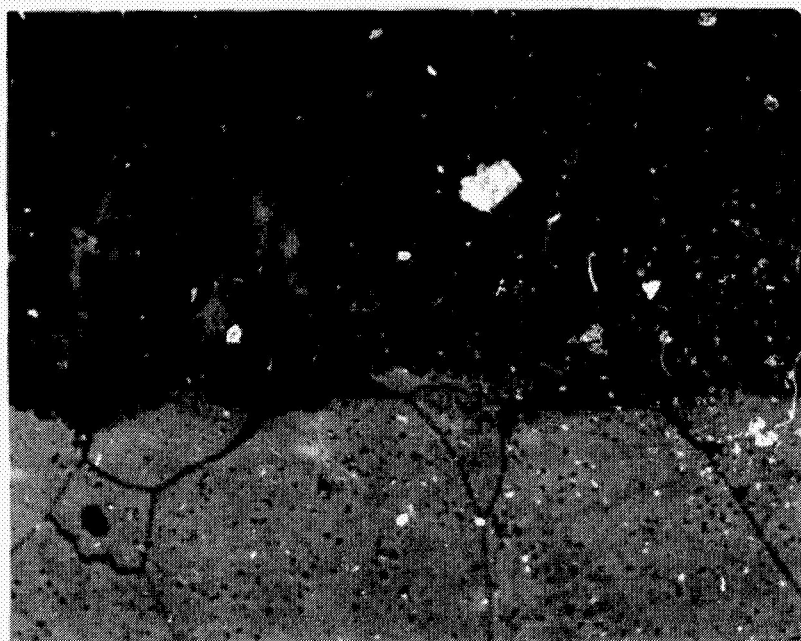
Another interesting feature of cracks in the HPOTP bearing raceway is the presence of oxide. For example, Figure 5 shows oxide films, 1 to 25 μm thick, usually present below the surface, starting at a depth of 0.076 mm (0.003 in.). There is no oxide film present on or near the surface, however. Furthermore, no such oxide film was observed in cracks in HPOTP bearing balls. The presence of an oxide film is indicative of elevated temperatures. Therefore, experiments were conducted to determine the temperature at which oxide layers, similar to the ones observed in the HPOTP bearing races, might form. A piece of 440C steel was heated to 482°C (900°F) and 816°C (1500°F) in air (20 percent O_2 , 79 percent N_2) for 1 hr each. The oxide film formed under these conditions was extremely thin, less than 1 μm . Only surface blackening occurred. At 1316°C (2400°F), however, a very thick, 0.635 mm (0.025 in.) oxide film was obtained in 30 min. The oxide film cracked and flaked off when cooling to room temperature. Figure 14 is a photomicrograph of oxide formed on the metal. The oxide is porous, and the metal-oxide interface is rough. By comparison, the oxide film in the HPOTP inner race does not contain pores (Fig. 7) and has a very smooth interface with the metal. The metal particles in the oxide appear round as opposed to irregularly shaped pieces in Figure 14. These results suggest that the oxide in the bearing races were probably formed at an elevated temperature high enough to melt the oxide. Once molten, the oxide could readily flow and fill up the cracks. An energy dispersive X-ray analysis of the oxide layer showed that the oxide had about the same ratio of iron to chromium (the two major components of 440C steel) as the parent metal. Temperatures in excess of 1400°C (2552°F) would be required to melt $\text{FeO-Cr}_2\text{O}_3$ at approximately 80 percent FeO [6]. However, the nature of the oxides formed at high oxygen pressures present in the turbopump is not known. Chromium is known to form high oxides (e.g., CrO_2 , CrO_3) at low temperatures and high oxygen pressures [7], but such information is lacking for iron. Handbook of Physics and Chemistry reports a melting point of 300°C

As noted earlier, no oxide film was observed on the raceway or immediately below it. The oxide appears to be located deeper inside, starting at 0.076 mm (0.003 in.). This result can be explained by the fact that the raceway is well cooled by liquid oxygen flowing at the surface but not deeper inside. Heat generated below the surface must be dissipated to the surface by conduction. This condition could result in subsurface areas running hotter than the surface during operation of the HPOTP. The heated region appears to be 0.076 to 0.25 mm (0.003 to 0.010 in.) deep.

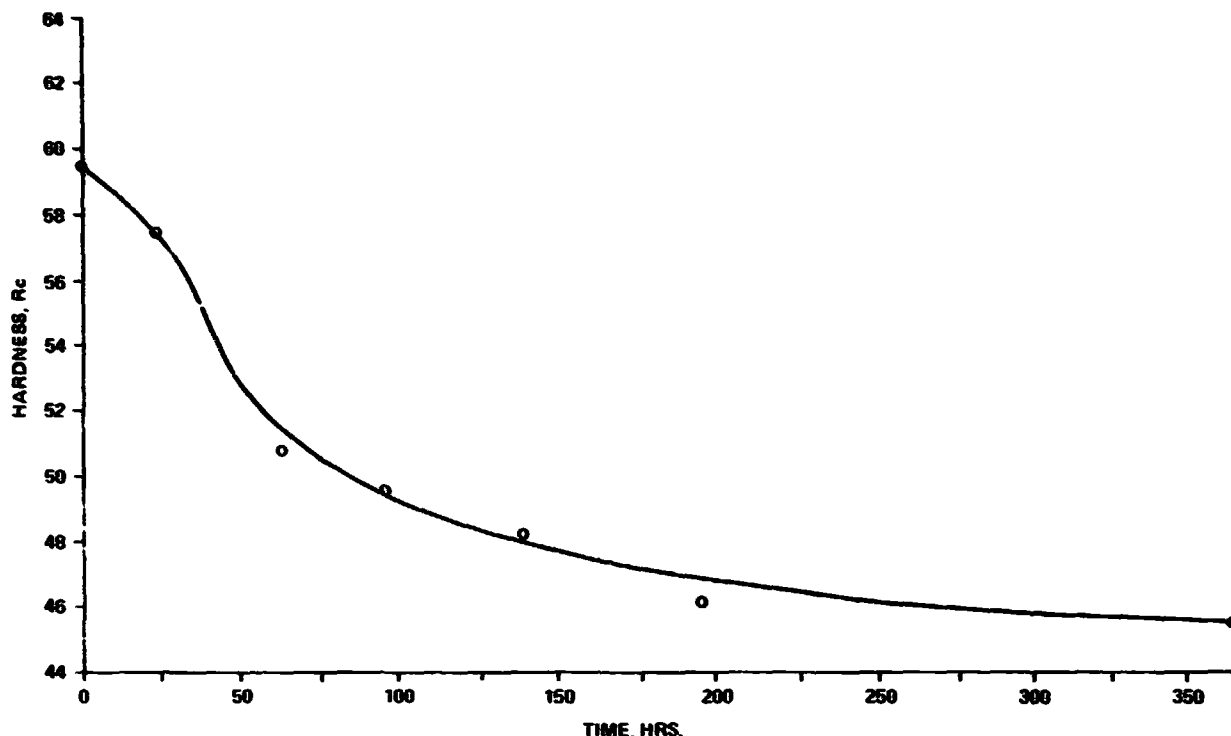
for CrO_2 and 196°C for CrO_3 , but these values are not supported by other workers in the field [7,8]. Binary phase diagrams of $\text{FeO}-\text{CrO}_3$ or $\text{FeO}-\text{CrO}_2$ are not available; hence, it is difficult to determine the melting temperature of the oxide found in the HPOTP bearing races operating in a high pressure oxygen environment. At the present time, however, available data strongly suggests that the HPOTP bearing raceways became locally very hot. There is no evidence of softening or tempering of martensite next to the oxide [1]. Figure 15 shows loss of hardness of martensite at 482°C (900°F) as a function of time for 440C steel. It takes approximately 12 hr at 482°C (900°F) to lose one point of hardness on the Rockwell C scale. Time taken for softening at elevated temperatures is not known but is likely to be shorter. At 1400°C (2552°F) significant softening may be expected in a matter of minutes. These considerations suggest that high temperatures, if attained, must have been localized and of short duration. Such localized heating could have resulted from plastic deformation under extremely high Hertzian stresses or from frictional heat generated by rubbing of fractured pieces of metal. Since the austenitizing temperature for 440C steel is approximately 1925°F, temperatures higher than this which were later quenched by lox may not show any loss of hardness.

Figure 15. Hardness versus time at 482°C (900°F) for 440C steel.

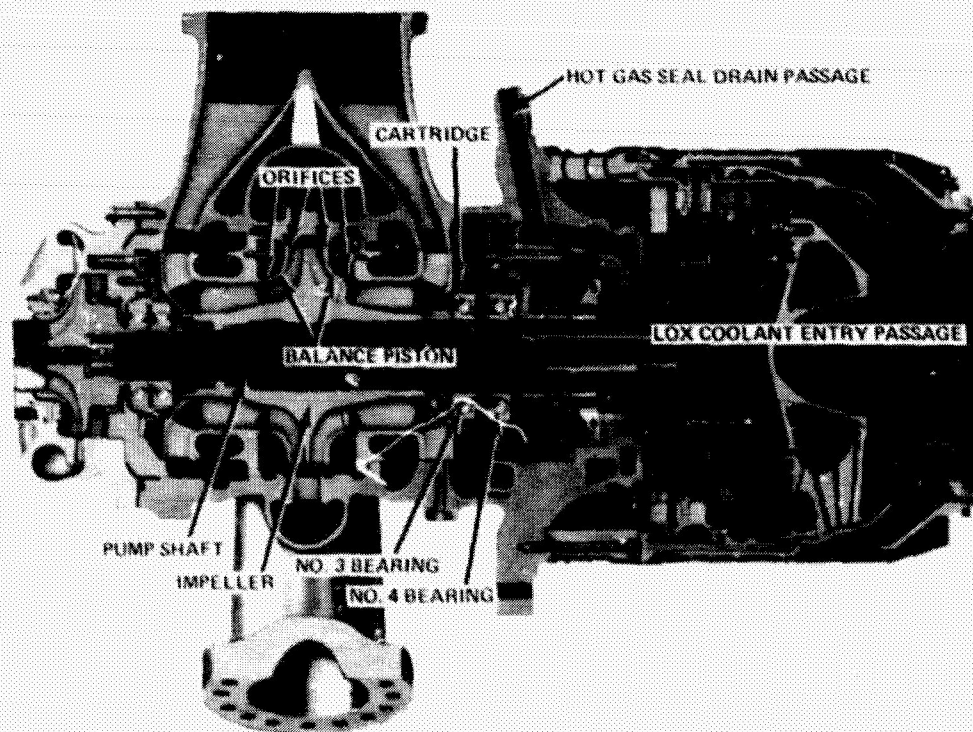
FIGURE 16. HIGH PRESSURE OXYGEN TURBOPUMP

Figure 16. High pressure oxygen turbopump.

This heat is dissipated by cold liquid oxygen flowing through the bearing. The liquid oxygen enters through bearing No. 4 and exits through bearing No. 3 (Fig. 16). For a HPOTP bearing operating under a nominal 725 kg (1600 lb) total load and 28,000 rpm, approximately 60 kW (56.9 Btu/sec) heat is generated with a favorable coefficient of friction (μ_f) of 0.10. Under less favorable conditions of $\mu_f = 0.22$, the heat generation is calculated to be 131 kW (124 Btu/sec), which is very high. Since heat generation is also a function of bearing load, abnormally high loads can be expected to generate even more heat and could cause serious overheating of the bearings. This will cause the bearings' inner races and balls to grow in size and reduce the bearings' internal clearances. This view is supported by a recent thermal study of HPOTP bearings by Battelle [10].
